CARDEN LAKE DAM

CRAWFORD COUNTY, MISSOURI

MISSOURI INVENTORY NO. 30987

PHASE 1 INSPECTION REPORT
NATIONAL DAM SAFETY PROGRAM

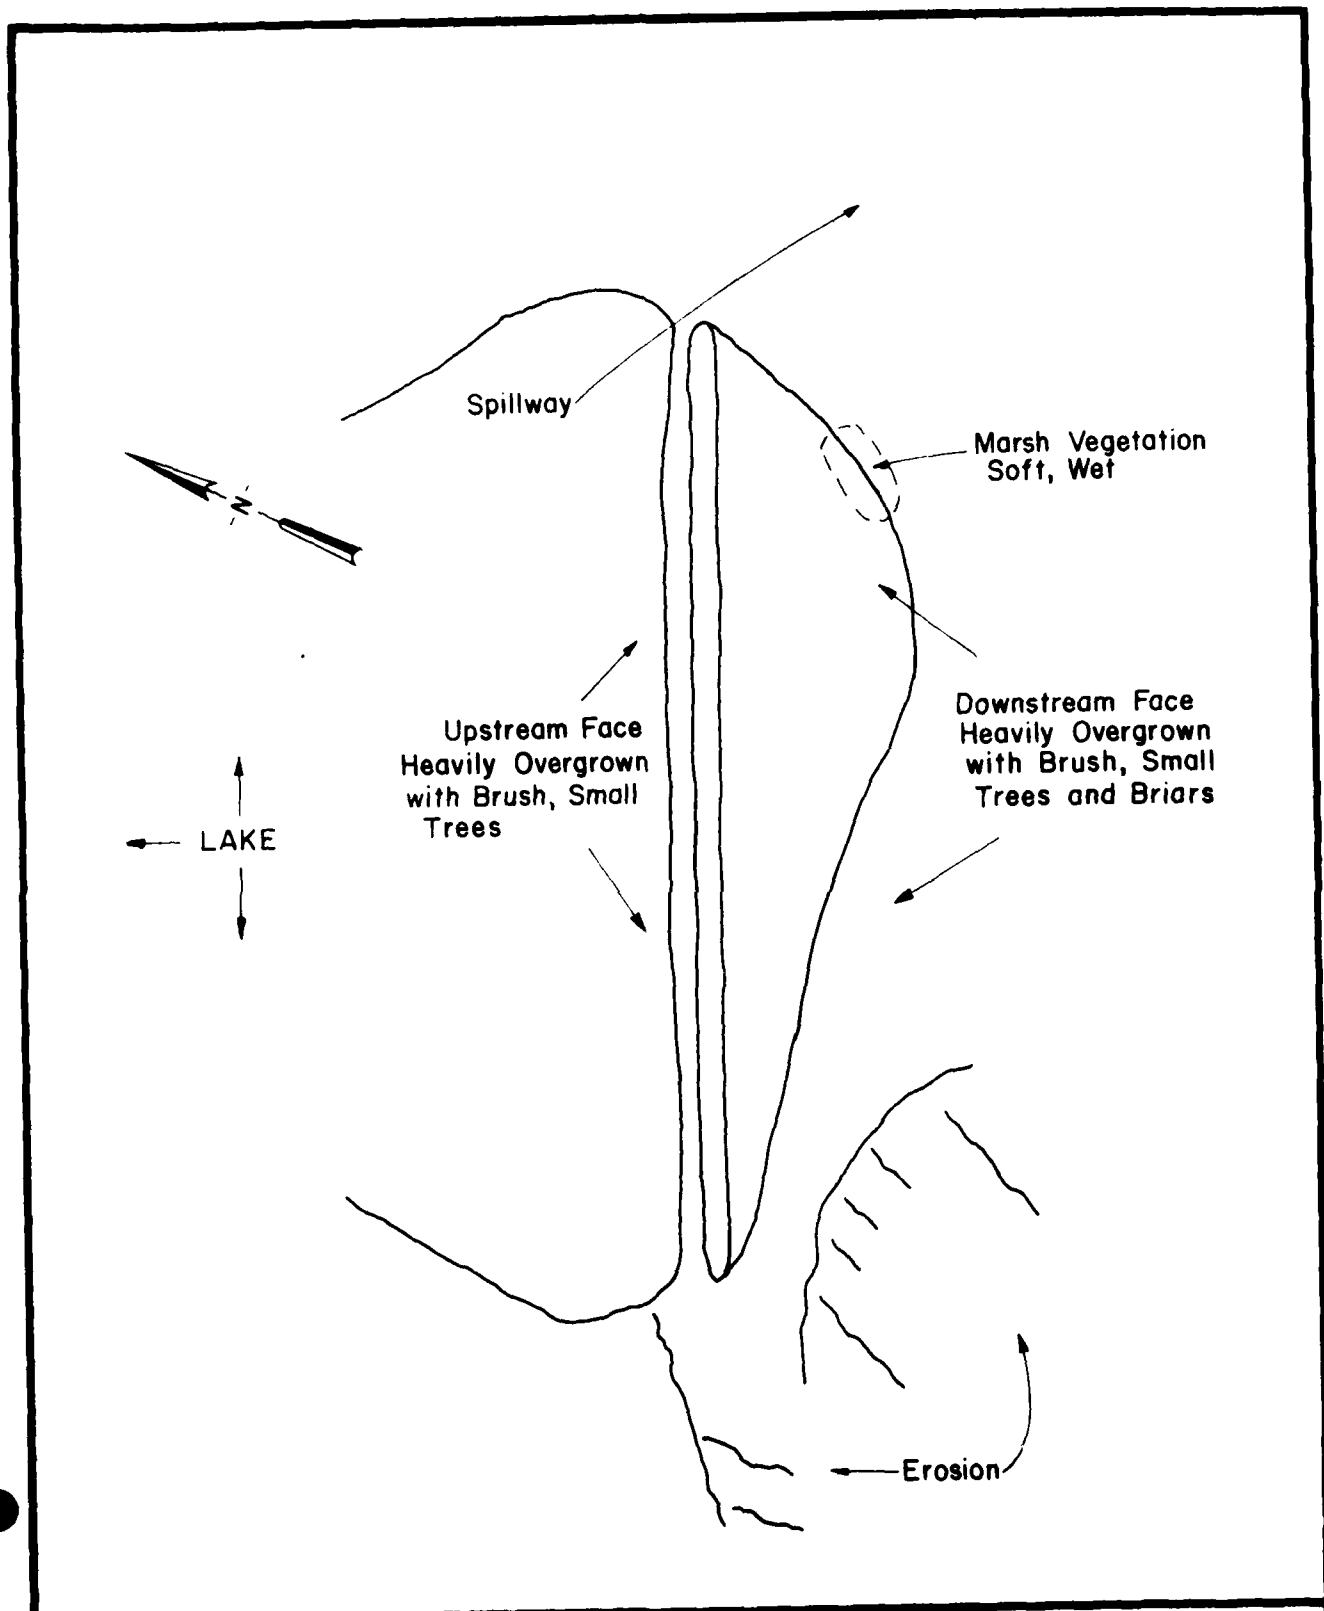
PLAN SKETCH OF FEATURES

A large erosion area was noted in the right abutment (see Sheet 5 of Appendix A). This area is somewhat apart from the dam and would not appear to affect the embankment stability.
